A-TEX INSPECTS

PROPERTY INSPECTION REPORT

Concerning: **Shadow Creek Ranch Address**

PRE-SLAB ADDENDUM PAGES

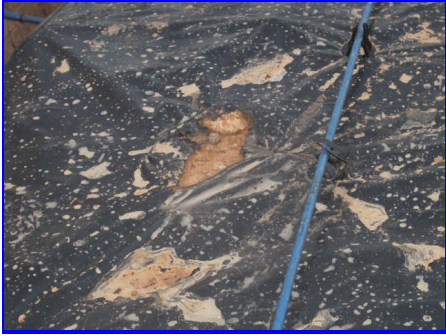
Repair all tears in the vapor barrier

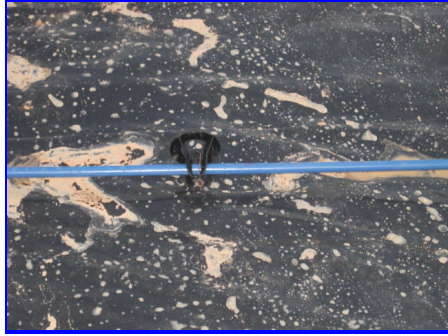
Numerous cable and rebar chairs are damaged or not sitting upright

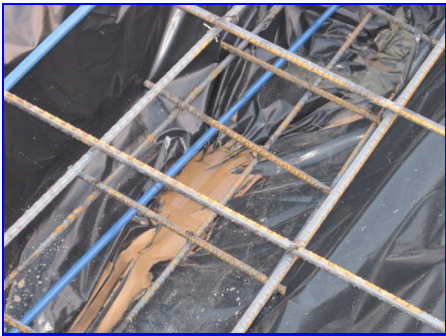
Water is standing in some of the footing trenches (Beams)

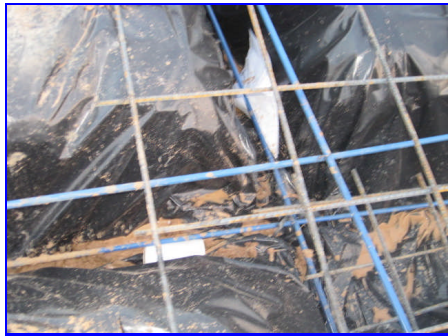
Remove all trash from footing trenches

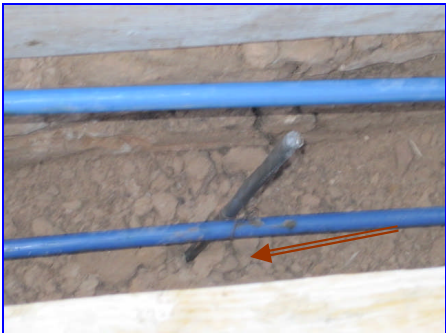
Vertical rebar supports should be on the inside of the form for the cable they are supporting

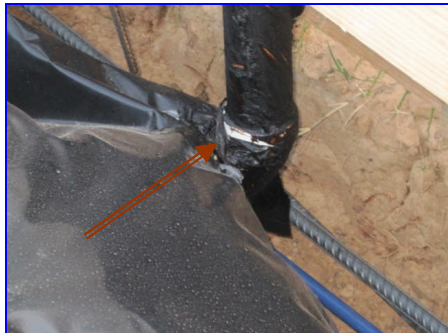
There are some portions of the plumbing that are not completely coated

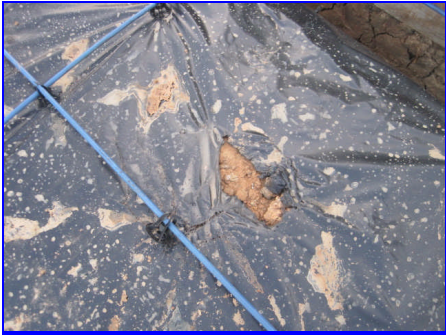
Repair tears in vapor barrier along the front center of the form

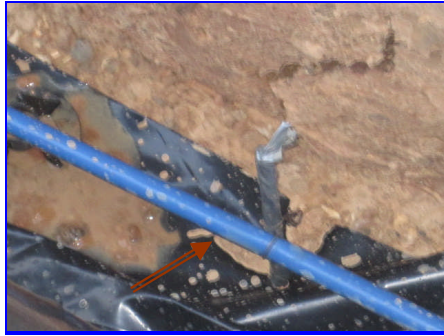
Vertical rebar supports should be on the inside of the form post-tension they are supporting

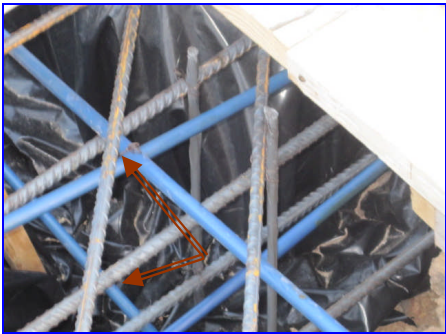
Several rebars are not tied at every junction

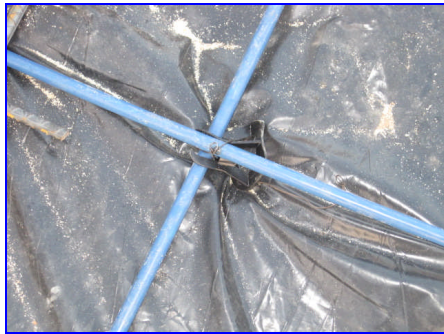
Several post-tension chairs are improperly placed or damaged

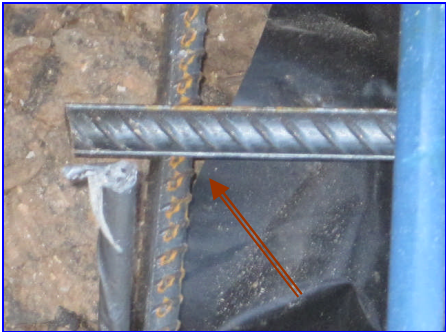
More photos of rebar ties missing at repair junctions

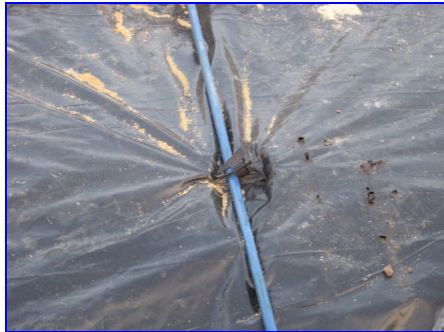
Damaged chairs are allowing cables to lie on top of the form

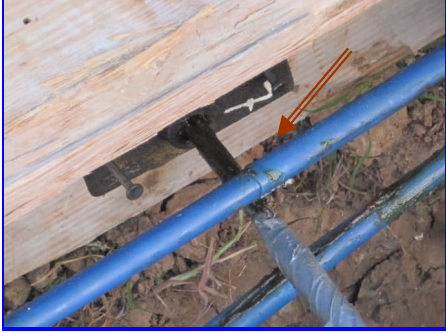
Portions of the post-tension cables on the anchor side are not covered

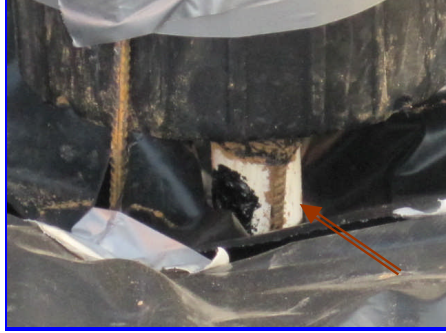
Plumbing not properly coated at left side of form

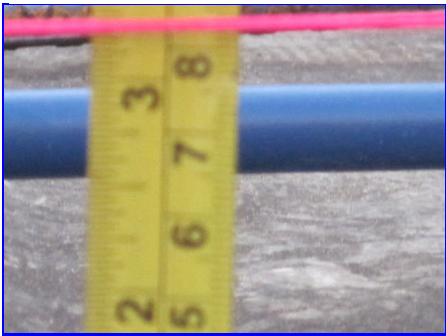
Slab thickness measures 3.25 inches at center rear area of the form

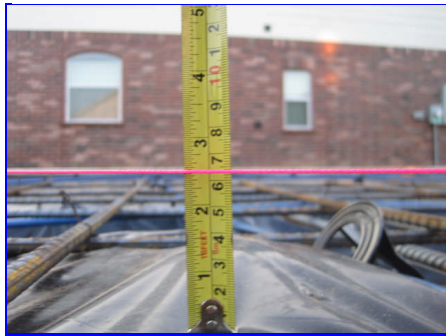
Slab depth measures 2.5 inches at the rear center portion of the form

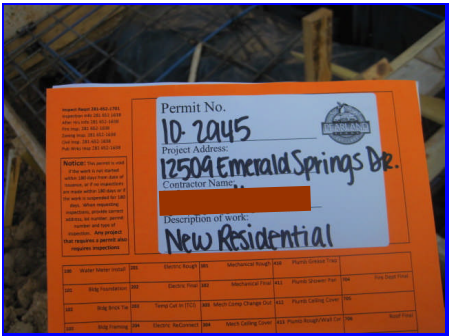
City Permit Issued - Inspector was on site a total of 3-4 minutes

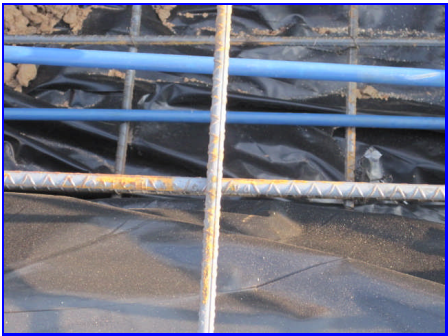
Note ties missing on several rebars and post-tension cables

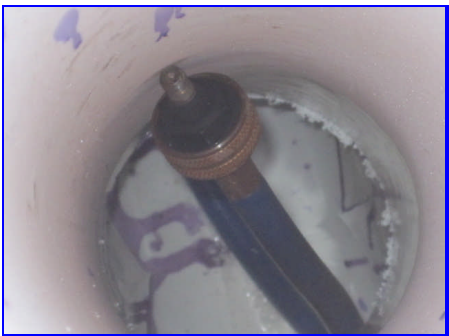
Head pressure line in front clean out drain
